Technical Note 5-70

NOISE REDUCTION OF THE XM759 CARGO CARRIER (MARGINAL TERRAIN VEHICLE)

Howard H. Holland, Jr.

July 1970

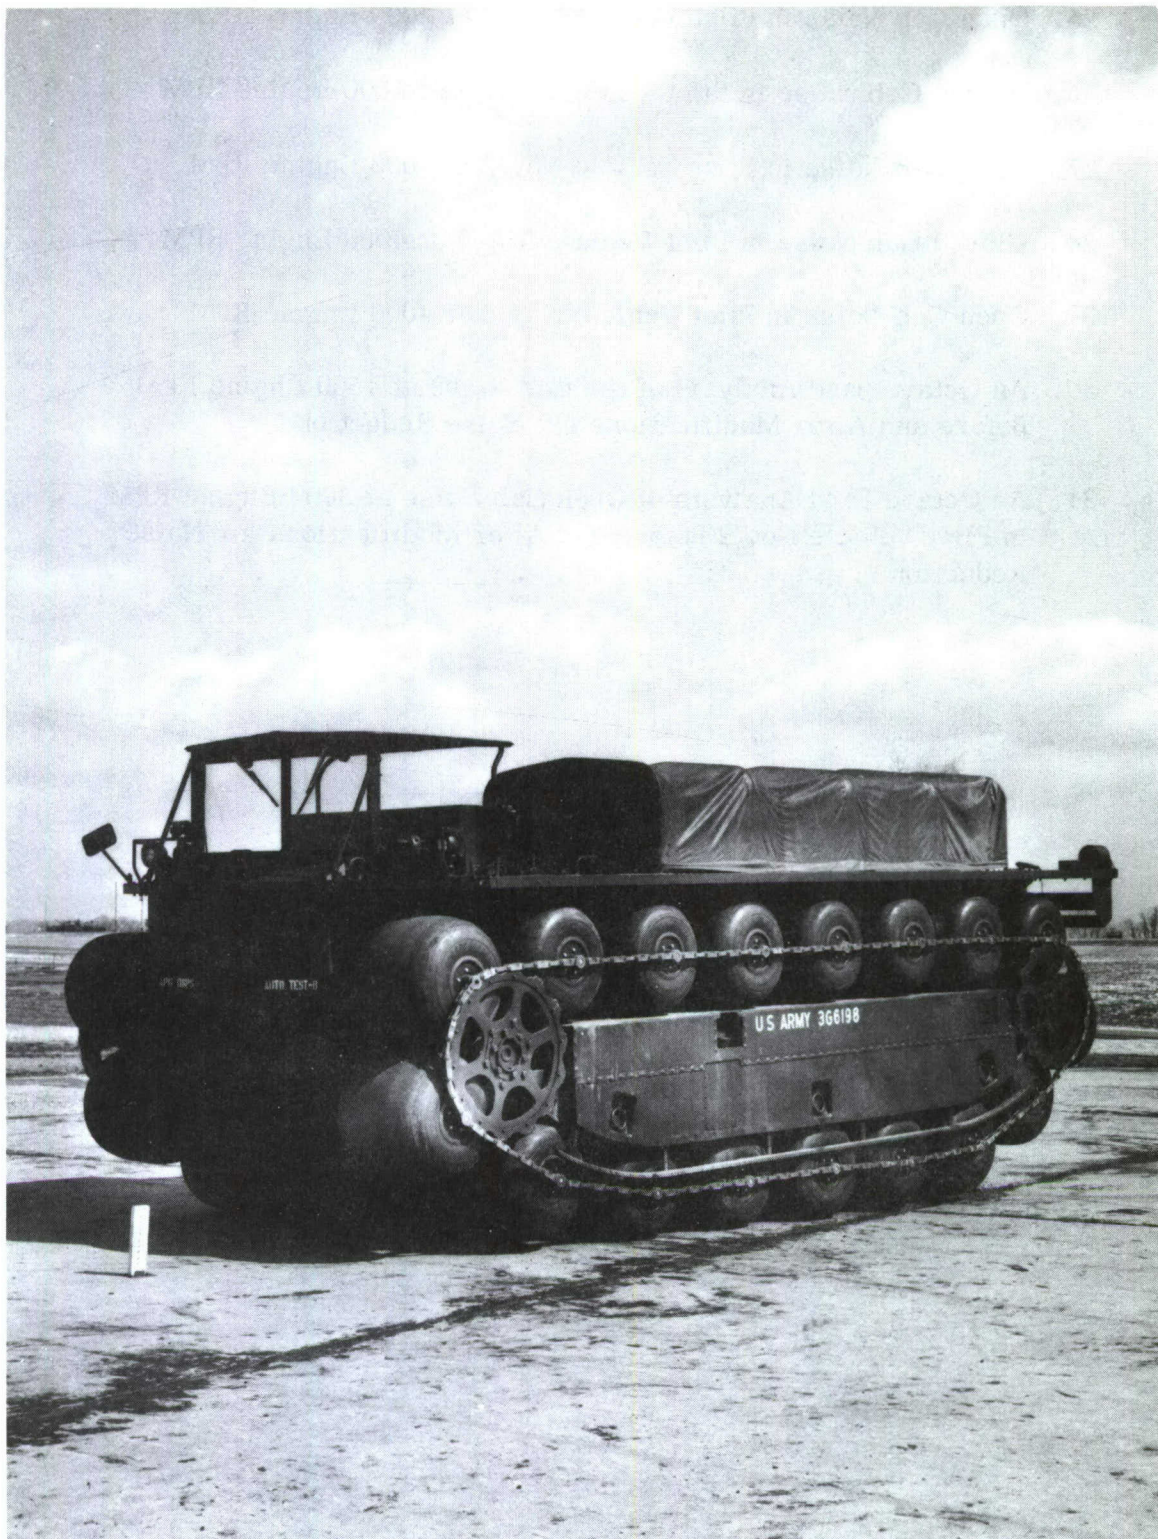
Fig. 1. THE XM759 CARGO CARRIER (MARGINAL TERRAIN VEHICLE)
PILOT VEHICLE NO. 3

- a. Initial noise measurements with Pilot Vehicle No. 3 in December 1967 at Aberdeen Proving Ground, Md. (Fig. 1).
- b. Measurements with Pilot Vehicle No. 6 in May 1968 at Fort Lee, Va. Acoustical material was added to the exhaust air shroud and the engine compartment.

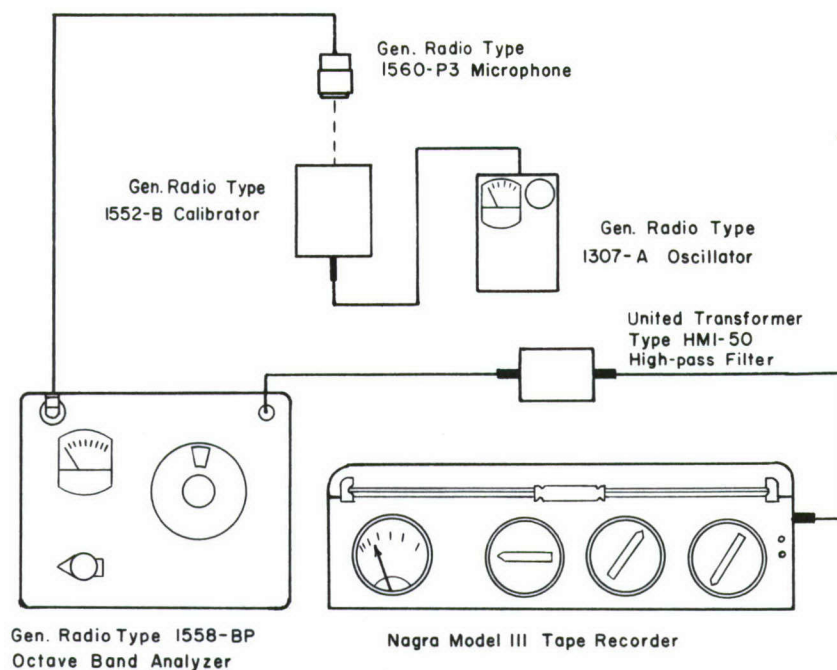
Fig. 2. SCHEMATIC DIAGRAM OF A TYPICAL MEASURING SYSTEM USED FOR MEASUREMENTS OF THE NOISE LEVELS OF THE XM759 CARGO CARRIER

The measuring system used in this noise-reduction program consisted of a General Radio (GR) octave-band analyzer and microphone. A Nagra Model III tape recorder was added to the system for some of the measurements to obtain recordings which could be played back for narrow-band analyses. The particular type or model number of the analyzer and microphone are given below for each individual set of measurements. A typical measuring system is shown in Figure 2.

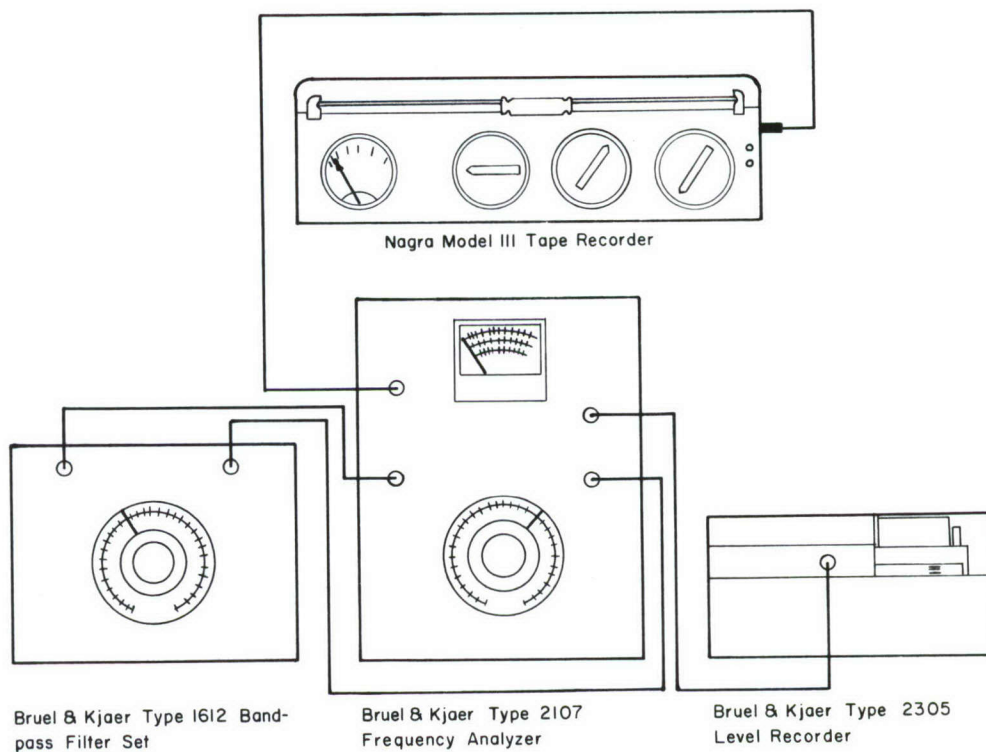
Fig. 3. ANALYZING SYSTEM FOR AUTOMATIC ANALYSIS OF THE XM759 CARGO CARRIER NOISE

The analyzing system consisted of the Bruel & Kjaer (B&K) equipment shown in Figure 3 plus the Nagra Model III recorder.

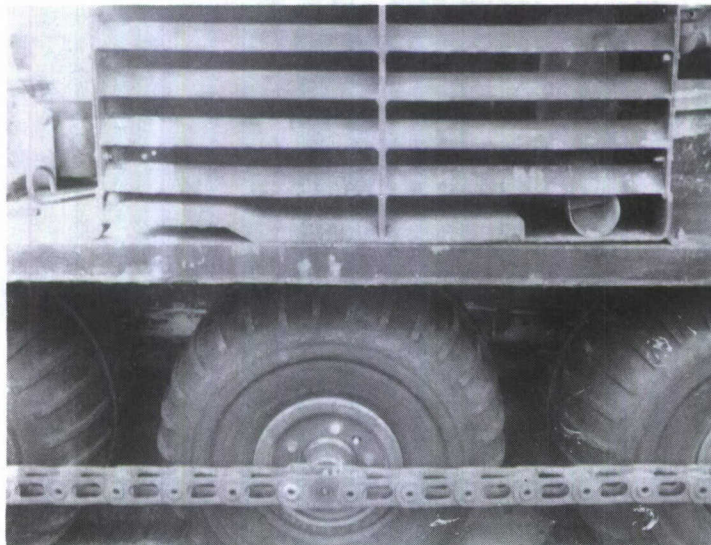
Fig. 5. VIEW OF EXHAUST AIR SHROUD WITH PLASTIC FOAM

On 10 July 1969, cab measurements (curtains up and curtains down) were made at 1000, 2000, 3000, 4000 and 4500 rpm after one-inch plastic foam had been installed in the exhaust air shroud (Fig. 5). Plastic foam was next installed in the radiator shroud and the cab measurements repeated, with the curtains down, at the same engine speeds. Next, the foam was added to the modified air intake and the measurements made with the curtains down.

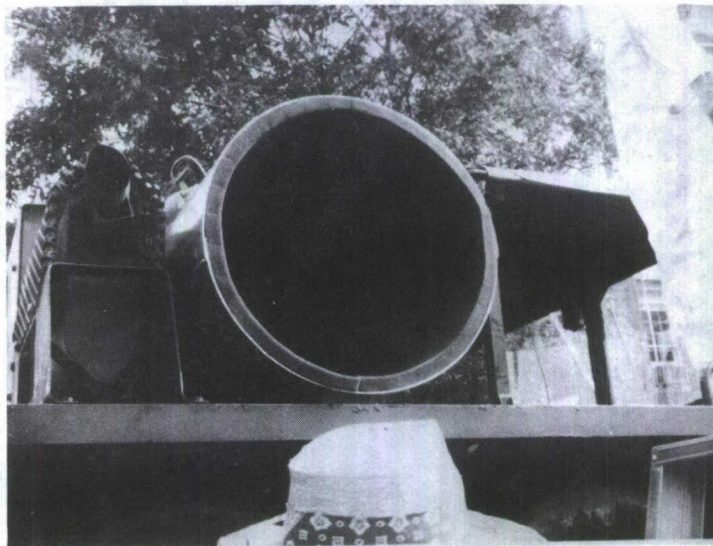
Fig. 6. VIEW OF CIRCULAR EXHAUST AIR DUCT LINED WITH PLASTIC FOAM

- a. Original rectangular duct installed on the exhaust side of the fan.
- b. Rectangular duct replaced by a circular duct having same diameter as the fan housing.
- c. No duct attached to the fan housing.
- d. Circular duct lined with the plastic foam (Fig. 6).
- e. Same as d plus three one-inch strips of the foam added axially to the existing foam liner.

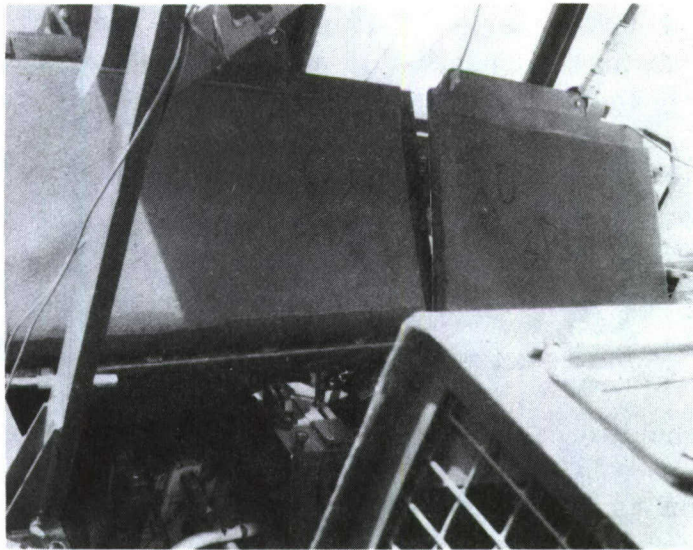
Fig. 7. VIEW OF PLASTIC FOAM ON BACK OF DRIVERS' SEATS

On 15 September 1969 foam was added to the back of the cab seats (Fig. 7) and to the interior of the engine access cover (Fig. 8). SPL's were then measured at 2000, 3000 and 4000 rpm with the cab open and closed. The circular duct was removed and a one-inch strip of foam was cemented to the interior of the fan housing between the fan blades and the stators. SPL's were measured at 2000, 3000 and 4000 rpm in the open cab with no duct attached to the fan housing. The circular duct with its foam liner was replaced and the measurements repeated. The next step was the addition of a vane to the interior of the circular duct. SPL's were then measured as before with and without foam on the vane.

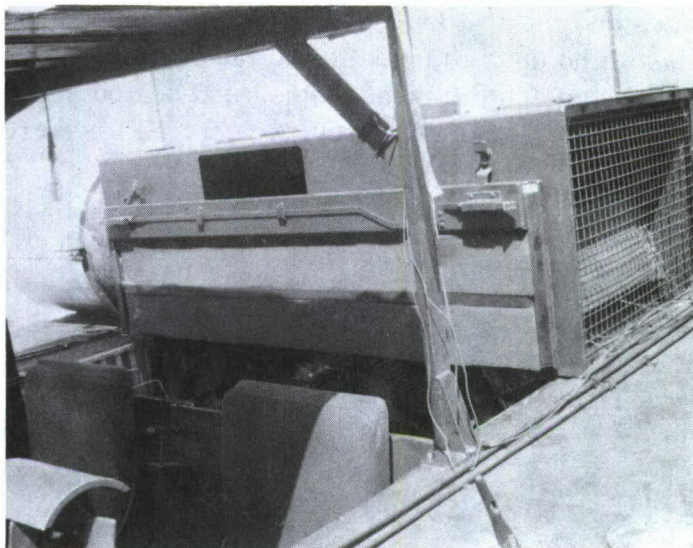
Fig. 8. ENGINE COOLING SYSTEM FOR PILOT VEHICLE NO. 2 WITH VIEW OF PLASTIC FOAM ON THE INTERIOR OF THE ENGINE ACCESS COVER

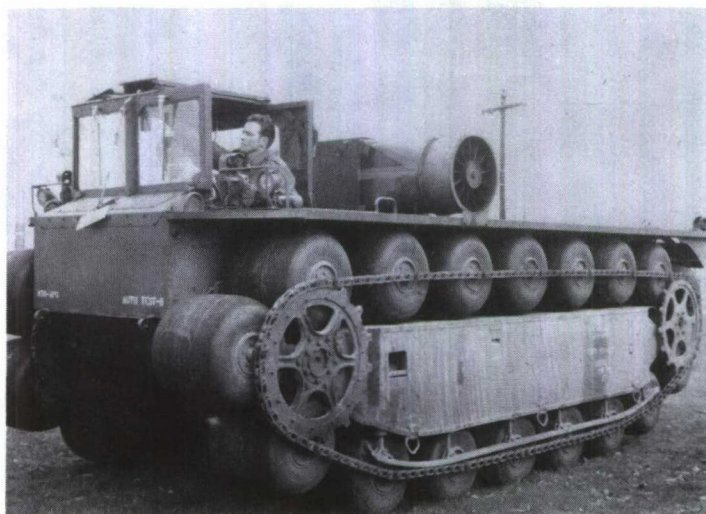
Fig. 9. PILOT VEHICLE NO. 2 WITH FAN MOUNTED ON LEFT SIDE

Testing was resumed on 19 November 1969, with the fan mounted on the left side of the vehicle (Fig. 9). The first measurements were made in the center of the open cargo area at head level of seated personnel (Fig. 10). They were made with no duct attached to the fan housing (see Fig. 9) and at 2000, 3000 and 4000 rpm. The next measurements were made at the same location in the cargo area with the Carr-Kalen (C-K) Attenuator shown in Figure 11. These measurements were made at 3000 and 4000 engine rpm.

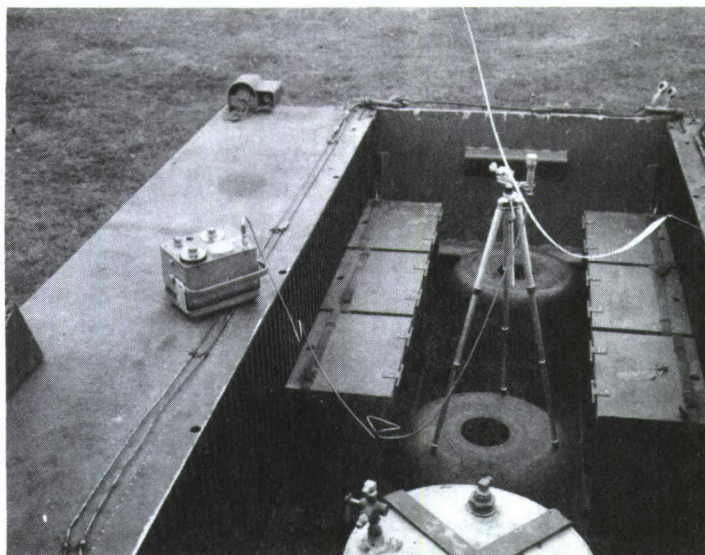
Fig. 10. VIEW OF MEASURING SYSTEM IN CARGO AREA OF PILOT VEHICLE NO. 2

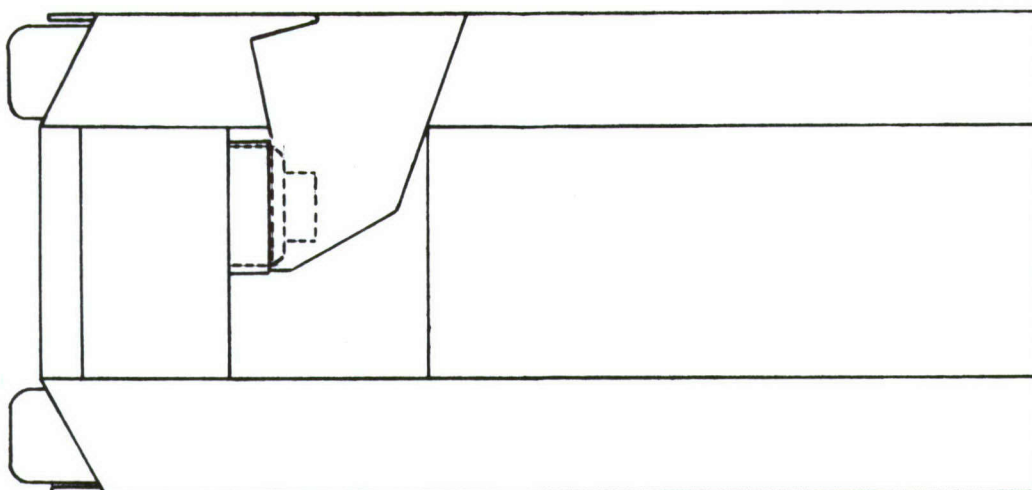
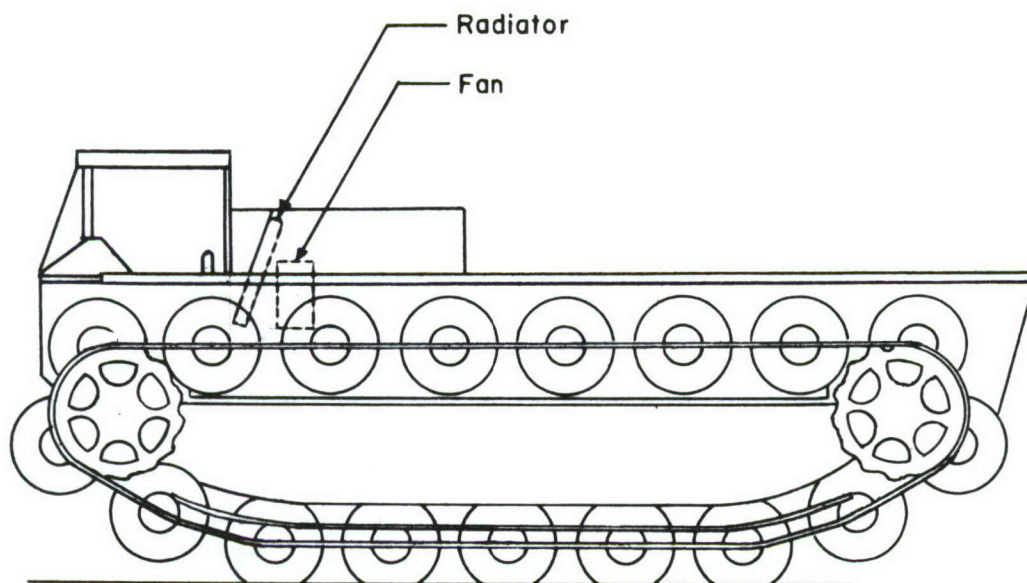
Fig. 12. VIEWS OF FAN AND RADIATOR IN PILOT VEHICLES NO. 3 AND NO. 6

The fan noise in Pilot Vehicles No. 3 and 6 was reduced by substituting a mixed-flow fan for the original axial-flow fan and by using acoustical material in the engine compartment, in the cooling system, and on the drivers' seats. In Pilot Vehicle No. 2, the fan noise was reduced by adding an attenuator to the exhaust side of the fan housing and foam in the engine compartment, in the cooling system, and on the drivers' seats. The attenuator helps to reduce the noise level but has the serious disadvantage of restricting the flow of cooling air and thereby raising the engine operating temperature.

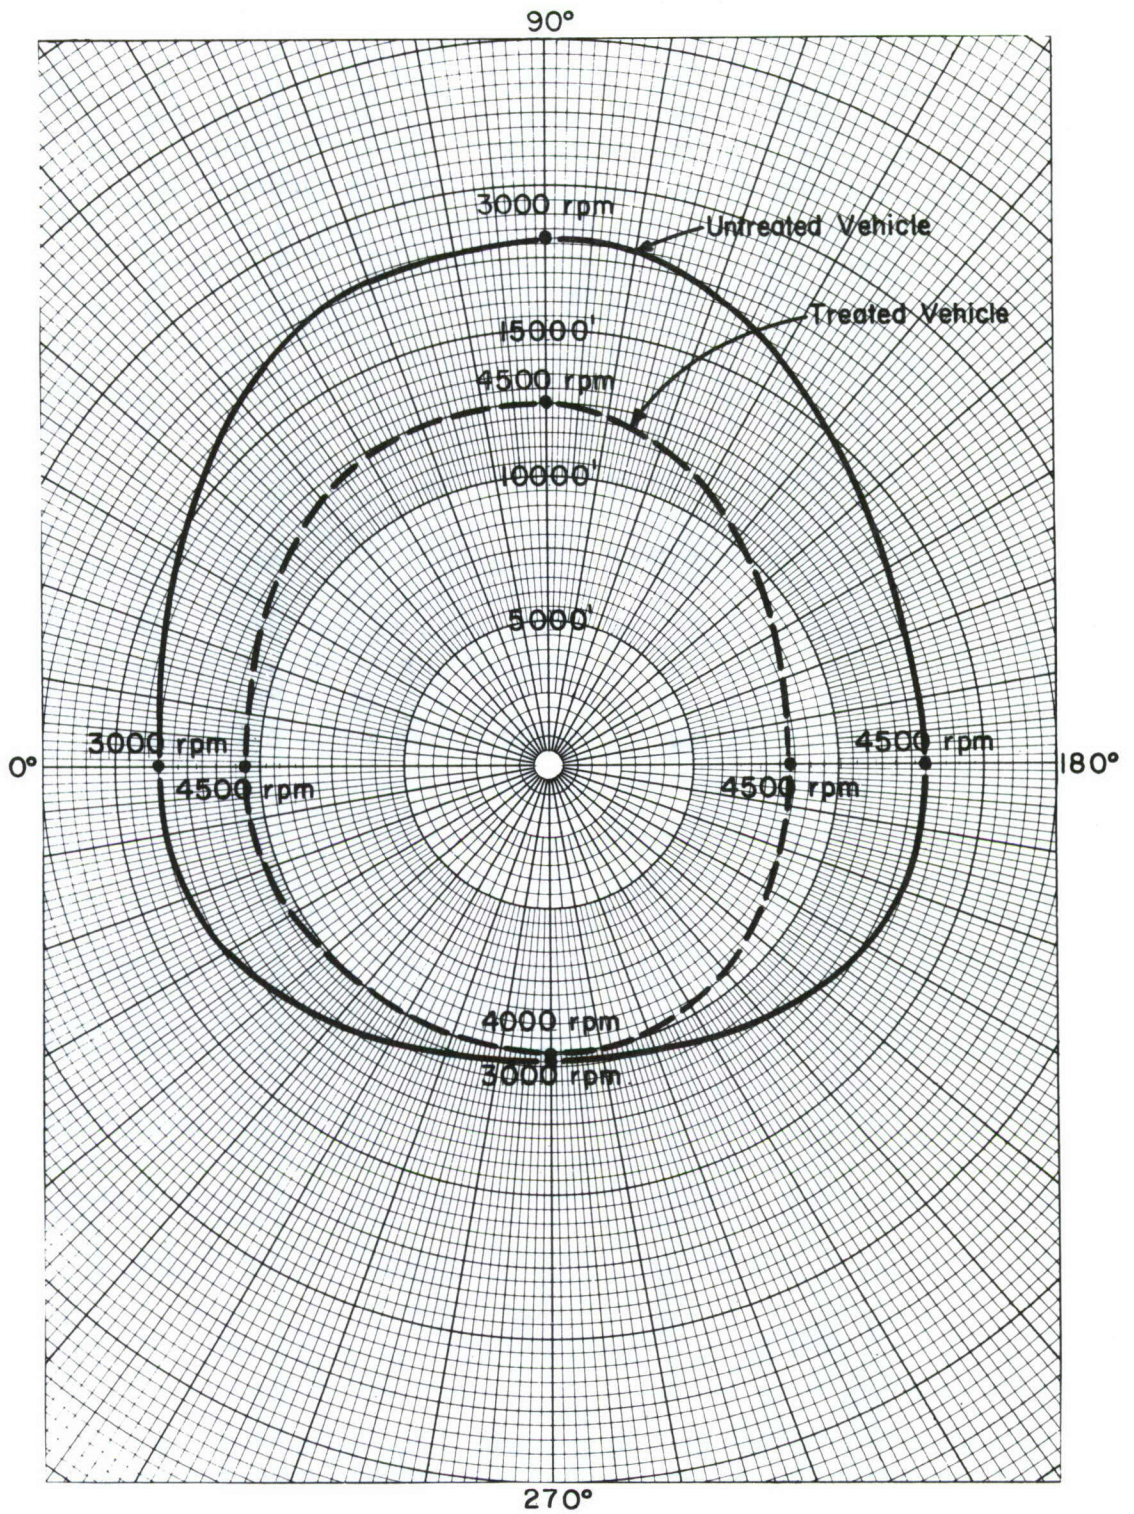
Fig. 13. DETECTION DISTANCES FOR AN UNTREATED AND TREATED PILOT VEHICLE NO. 6. VEHICLE HEADING IS 0°

Another presentation is one showing detection distances for an acoustically treated vehicle versus an untreated vehicle. Pilot Vehicle No. 6 was used for these measurements and the distances are shown in Figure 13. These distances represent those distances which a person with keen hearing could hear the noise from the XM759 Cargo Carrier.

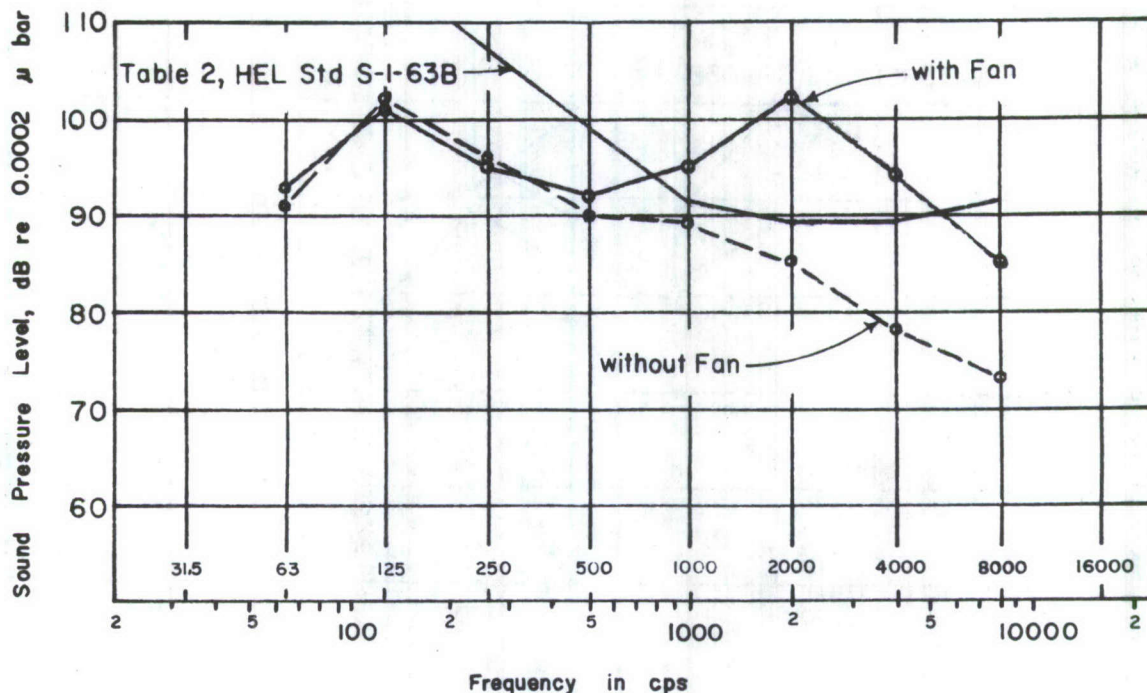
Fig. 14. OCTAVE BAND ANALYSES OF NOISE IN CAB OF PILOT VEHICLE NO. 3 AT 4000 ENGINE RPM WITH AND WITHOUT THE FAN

The main source of noise in the XM759 Cargo Carrier is the engine cooling fan. This is vividly revealed by Figures 14 and 15, with and without the operation of the fan. High-speed cooling fan noise is a problem in many U. S. Army vehicles.

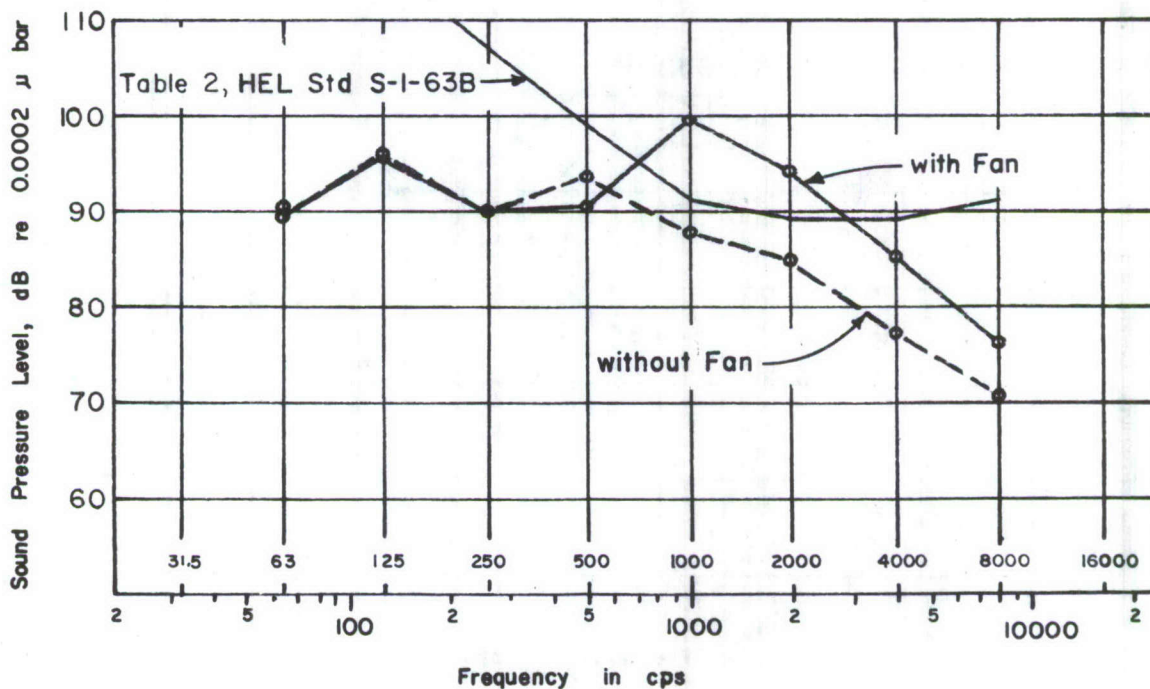
Fig. 15. OCTAVE BAND ANALYSES OF NOISE IN CAB OF PILOT VEHICLE NO. 2 AT 4000 ENGINE RPM WITH AND WITHOUT THE FAN

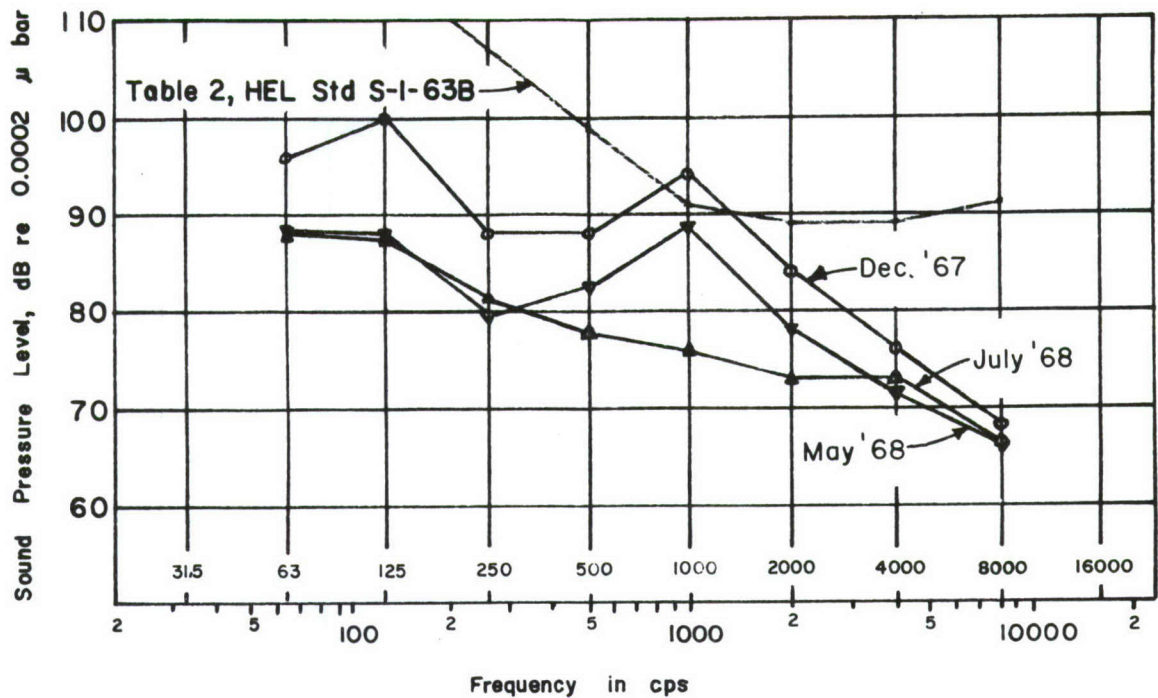
Fig. 16. CAB NOISE IN PILOT VEHICLE NO. 3 (DEC 1967) AND PILOT VEHICLE NO. 6 (MAY & JULY 1968) AT 2000 ENGINE RPM. CAB WAS CLOSED EXCEPT FOR PILOT VEHICLE NO. 3 WHERE DRIVER'S CURTAIN WAS OFF

All of the noise level results presented in this report are data obtained in the drivers' cab with the vehicles stationary and with the engines and cooling fans operating (except for the few cases when the fans were disconnected). The presentation of data involves Pilot Vehicles No. 2, No. 3 and No. 6. Data for Pilot Vehicles No. 3 and No. 6 have been presented on the same figures, while data for Pilot Vehicle No. 2 have been presented on separate figures. The reason for this method of presentation was the difference in location of the engine cooling system. Pilot Vehicles No. 3 and 6 had a system drawing air into the radiator directly behind the cab and exhausting the air out on the right side of the vehicles (Fig. 12). Pilot Vehicle No. 2 had a system drawing air in on one side of the vehicle and exhausting it on the opposite side (Fig. 8). The SPL results by octave bands are shown in Figures 14-31.

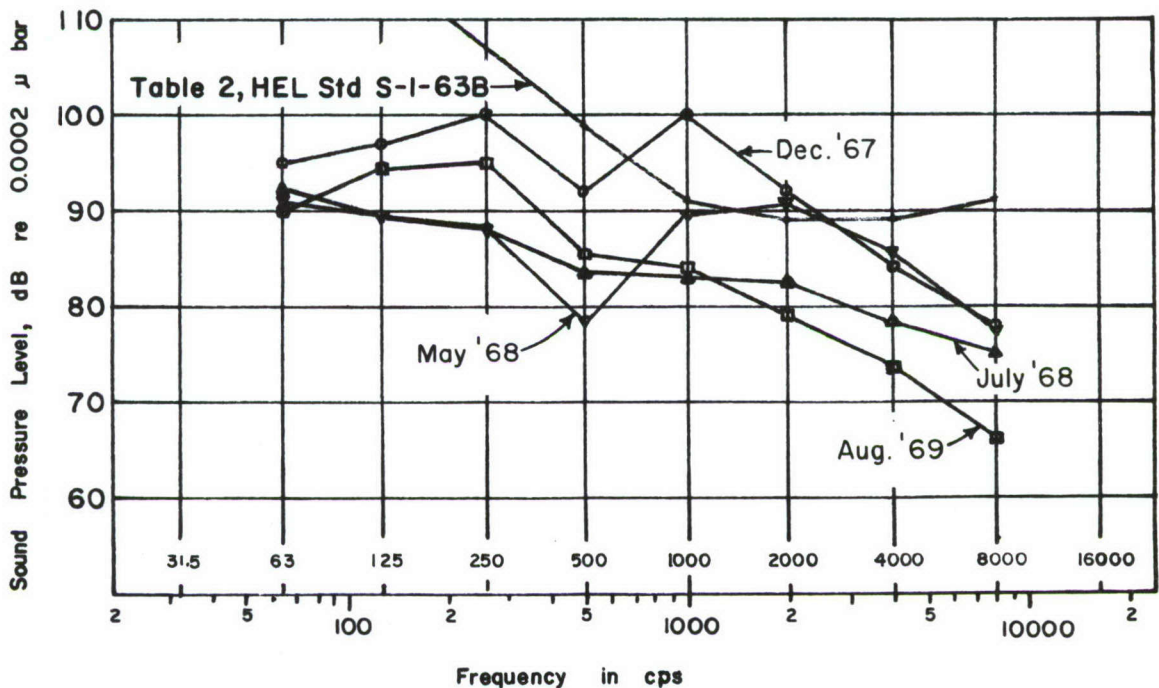
Fig. 17. CAB NOISE IN PILOT VEHICLE NO. 3 (DEC 1967) AND PILOT VEHICLE NO. 6 (MAY & JULY 1968; AUG 1969) AT 3000 ENGINE RPM. CAB WAS CLOSED EXCEPT FOR PILOT VEHICLE NO. 3 WHERE DRIVER'S CURTAIN WAS OFF

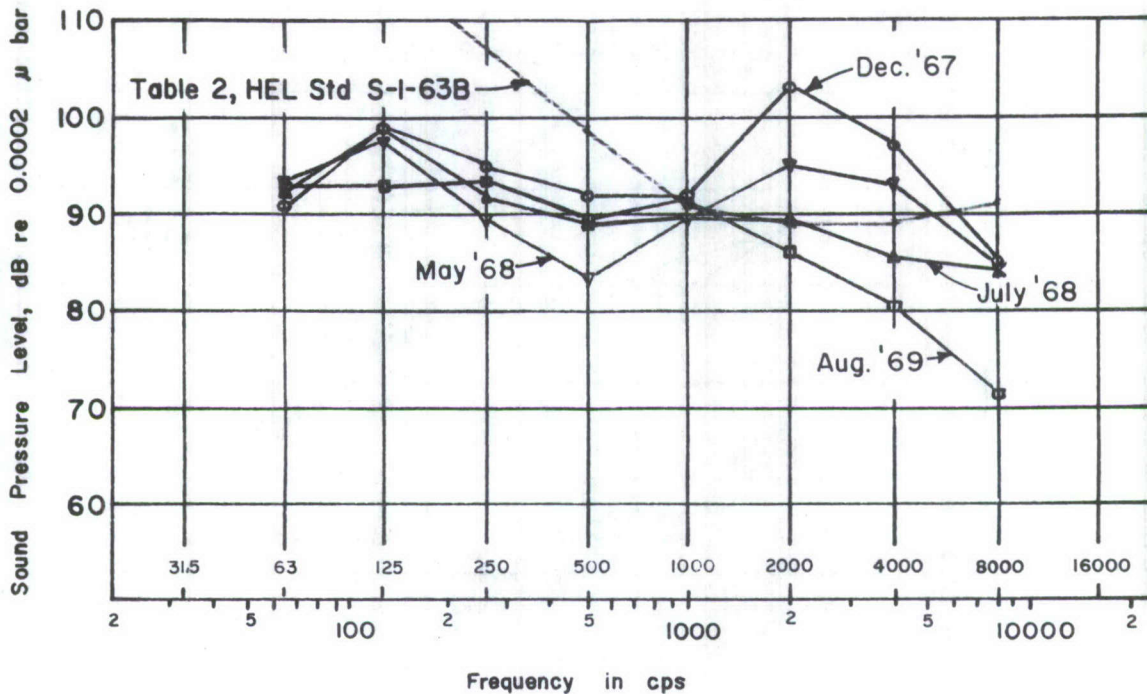
Fig. 18. CAB NOISE IN PILOT VEHICLE NO. 3 (DEC 1967) AND PILOT VEHICLE NO. 6 (MAY & JULY 1968; AUG 1969) AT 4000 ENGINE RPM . CAB WAS CLOSED EXCEPT FOR PILOT VEHICLE NO. 3 WHERE DRIVER'S CURTAIN WAS OFF

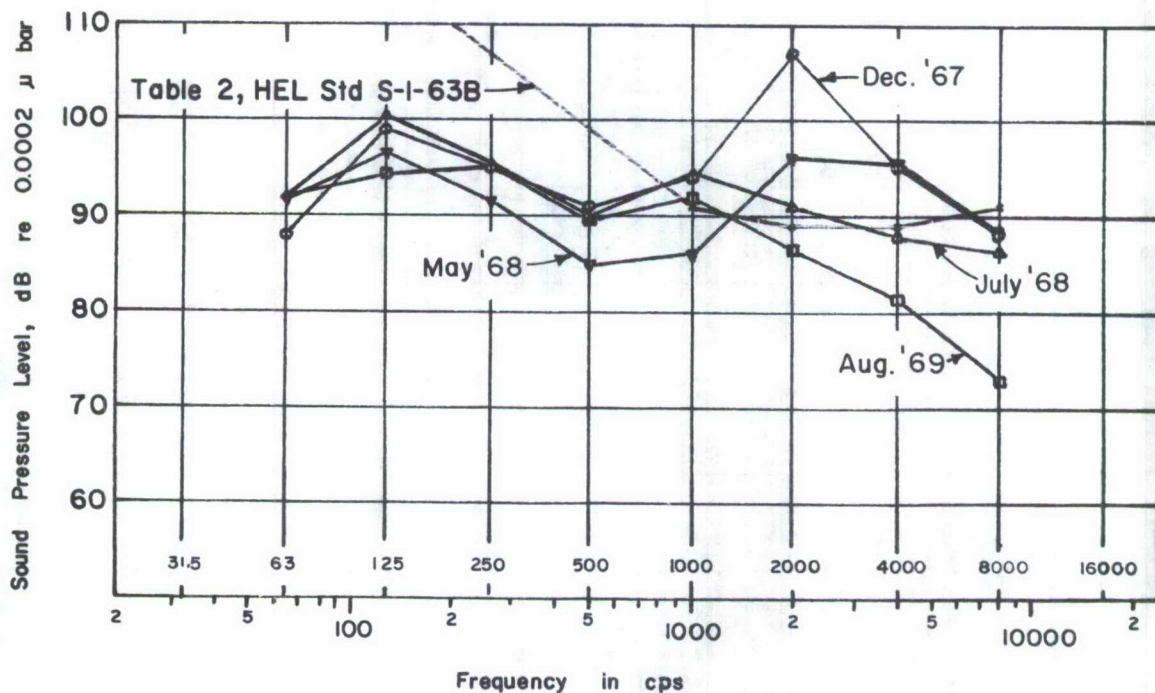
Fig. 19. CAB NOISE IN PILOT VEHICLE NO. 3 (DEC 1967) AND PILOT VEHICLE NO. 6 (MAY & JULY 1968; AUG 1969) AT 4500 ENGINE RPM. CAB WAS CLOSED EXCEPT FOR PILOT VEHICLE NO. 3 WHERE DRIVER'S CURTAIN WAS OFF

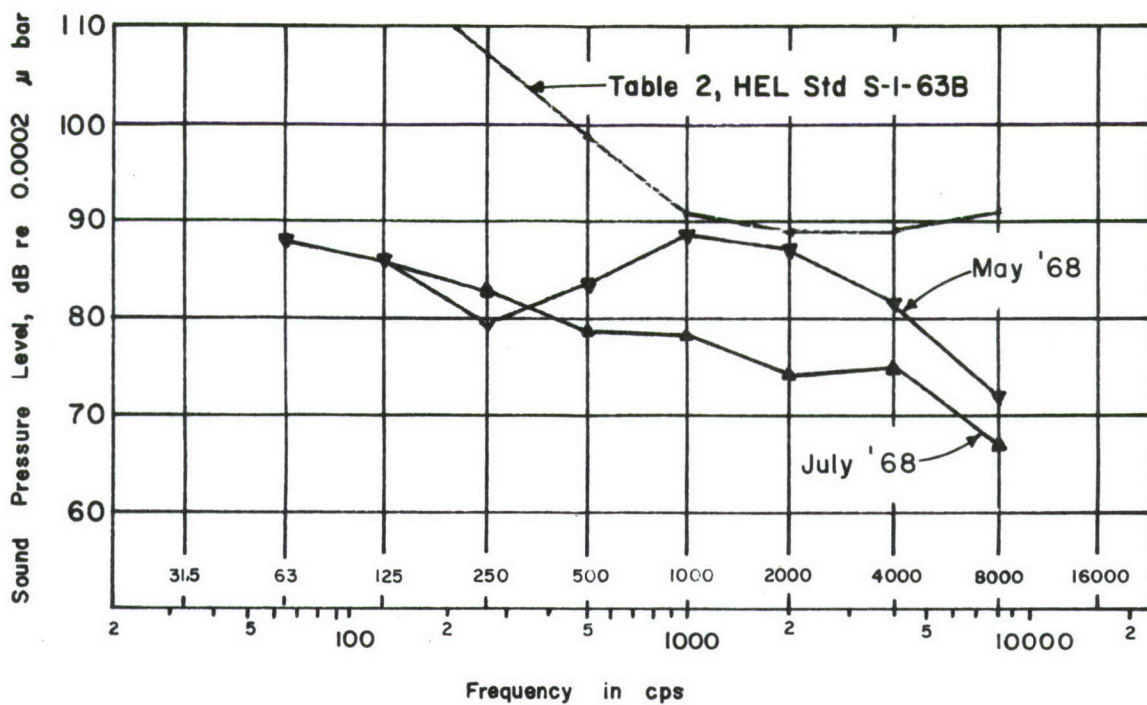
Fig. 20. OPEN CAB NOISE IN PILOT VEHICLE NO. 6 AT 2000 ENGINE RPM

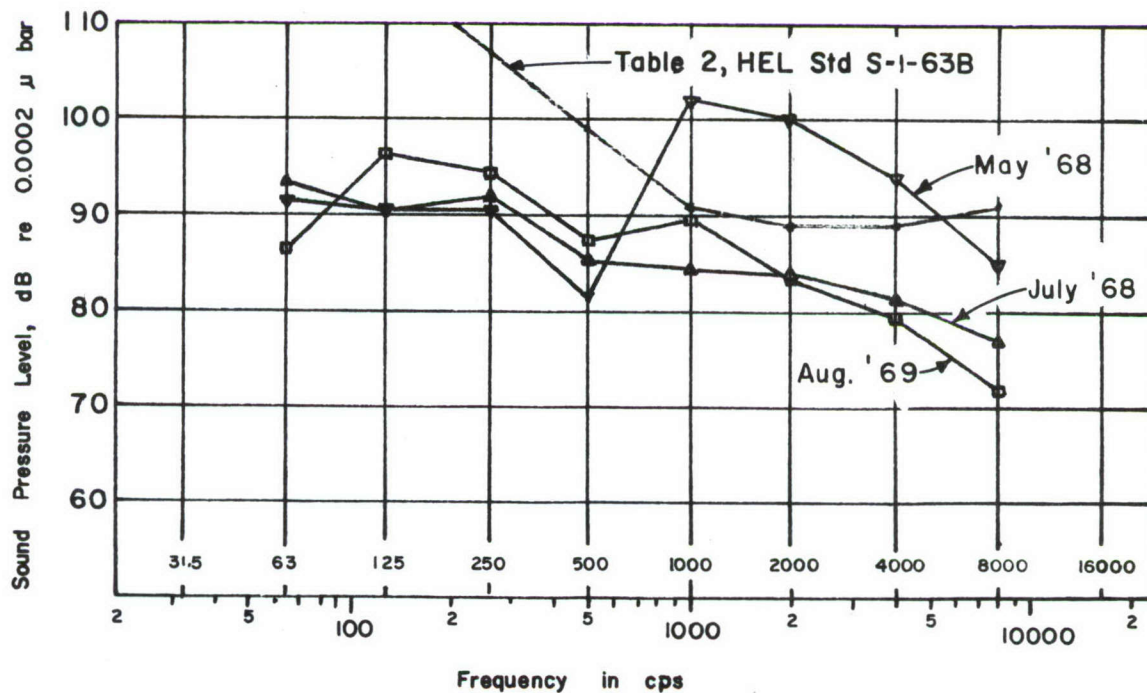
Fig. 21. OPEN CAB NOISE IN PILOT VEHICLE NO. 6 AT 3000 ENGINE RPM

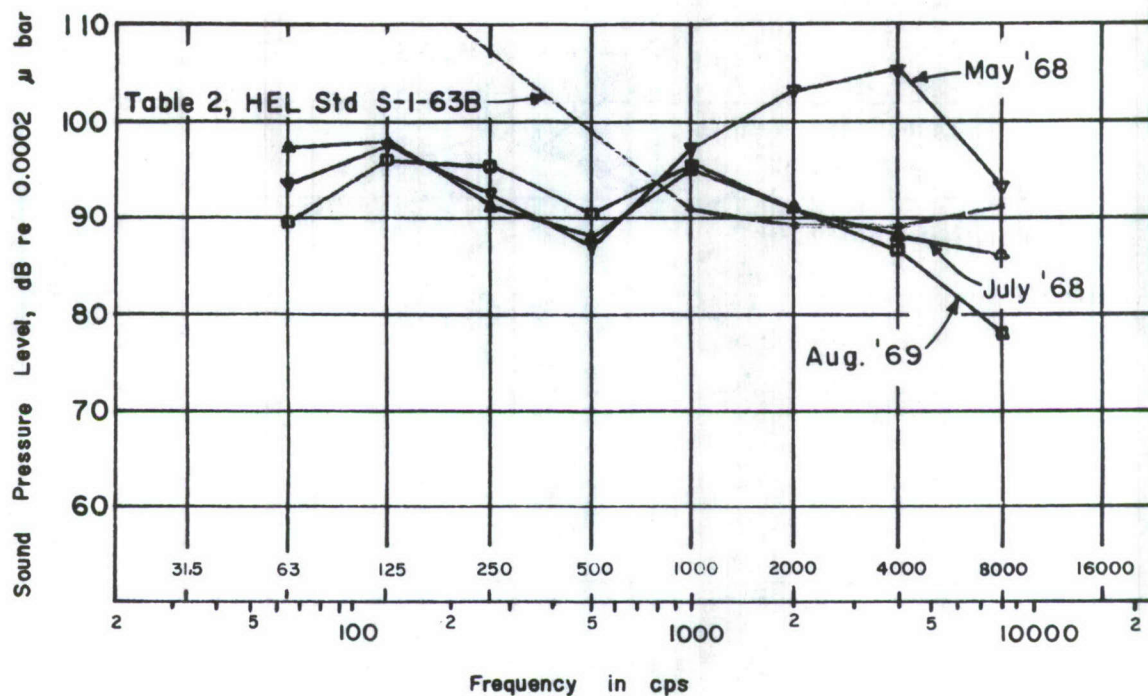
Fig. 22. OPEN CAB NOISE IN PILOT VEHICLE NO. 6 AT 4000 ENGINE RPM

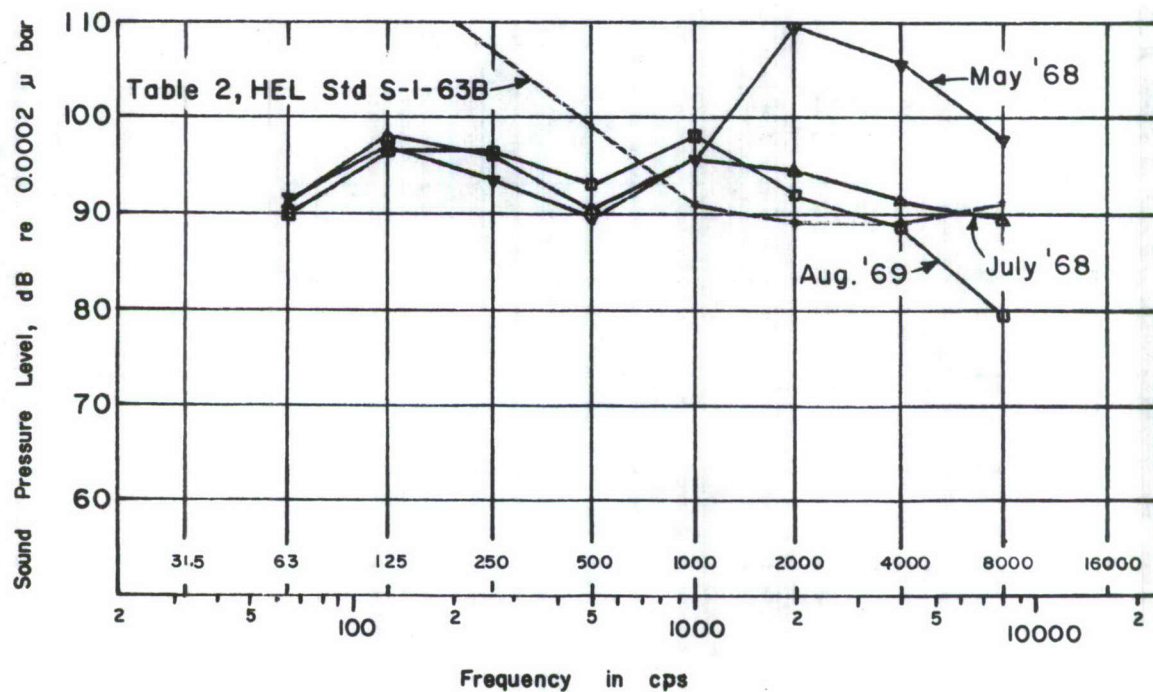
Fig. 23. OPEN CAB NOISE IN PILOT VEHICLE NO. 6 AT 4500 ENGINE RPM

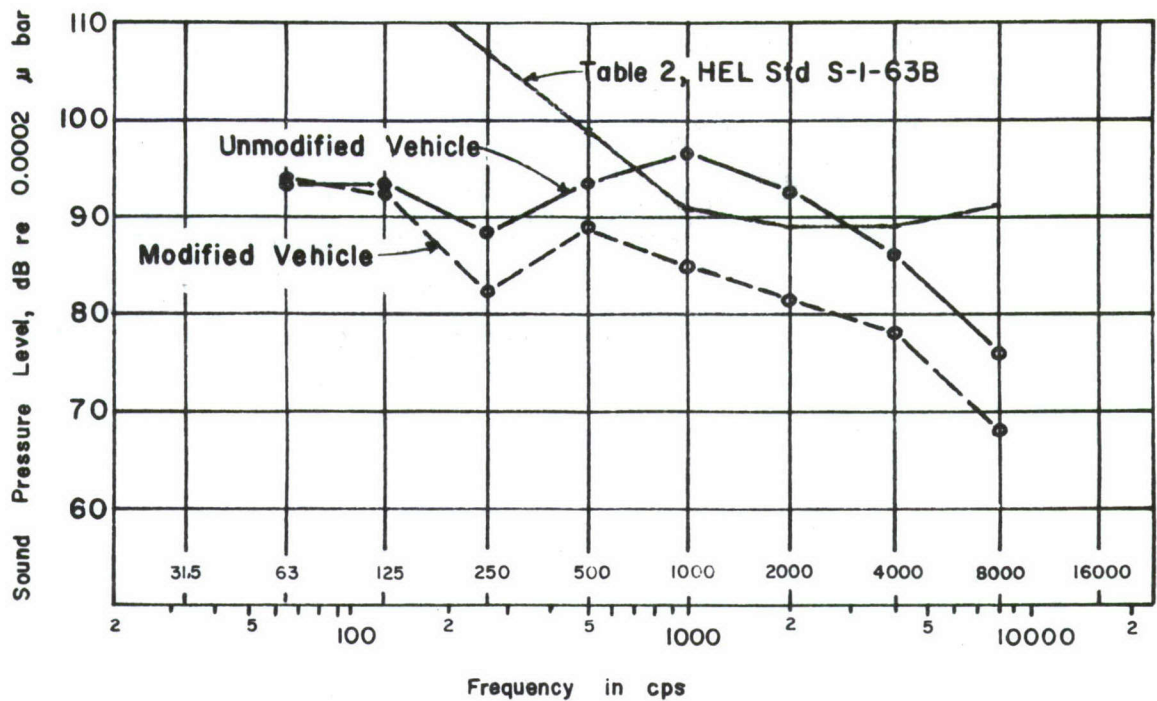
Fig. 24. CLOSED CAB NOISE IN PILOT VEHICLE NO. 2 AT 2000 ENGINE RPM

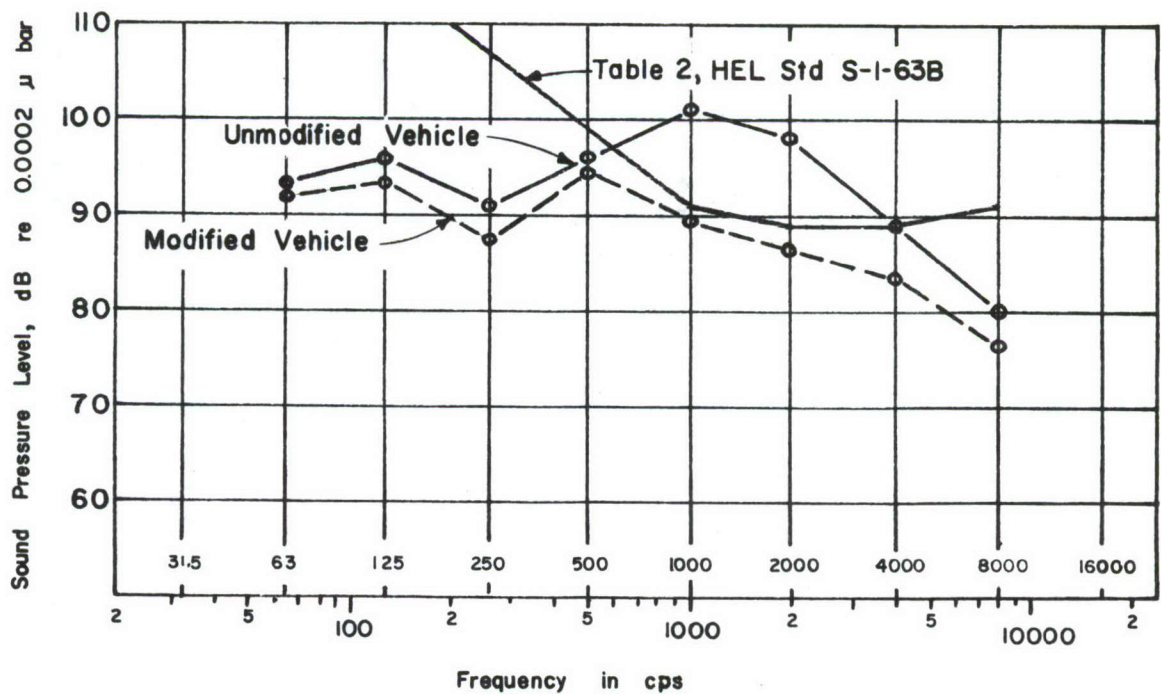
Fig. 25. OPEN CAB NOISE IN PILOT VEHICLE NO. 2 AT 2000 ENGINE RPM

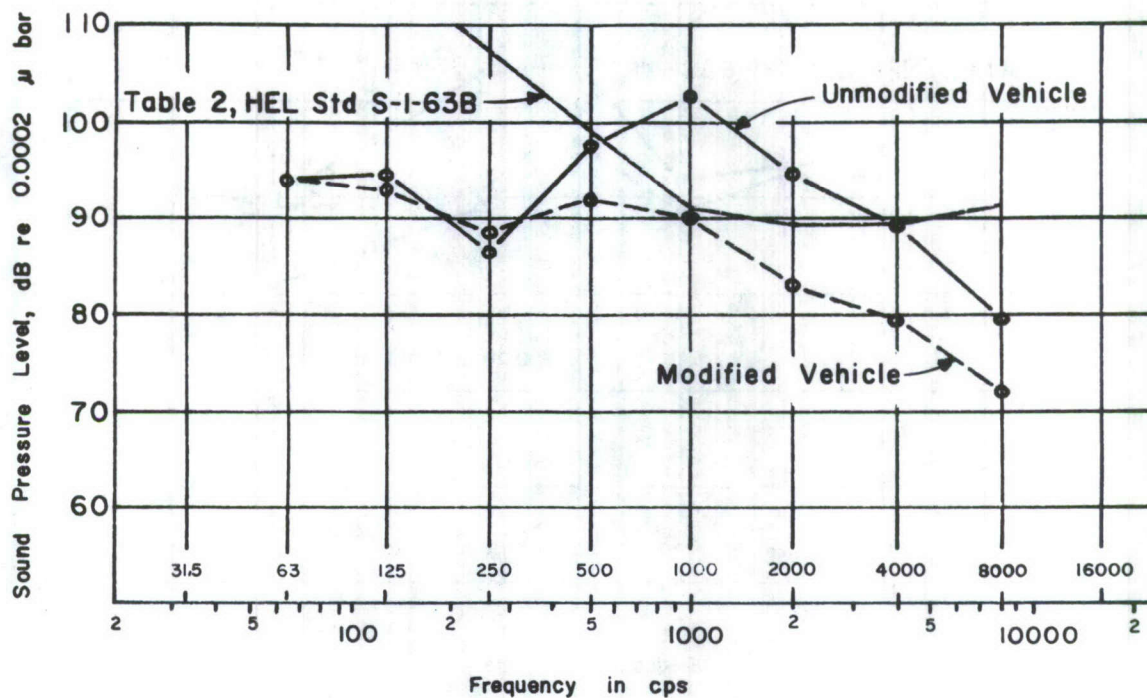
Fig. 26. CLOSED CAB NOISE IN PILOT VEHICLE NO. 2 AT 3000 ENGINE RPM

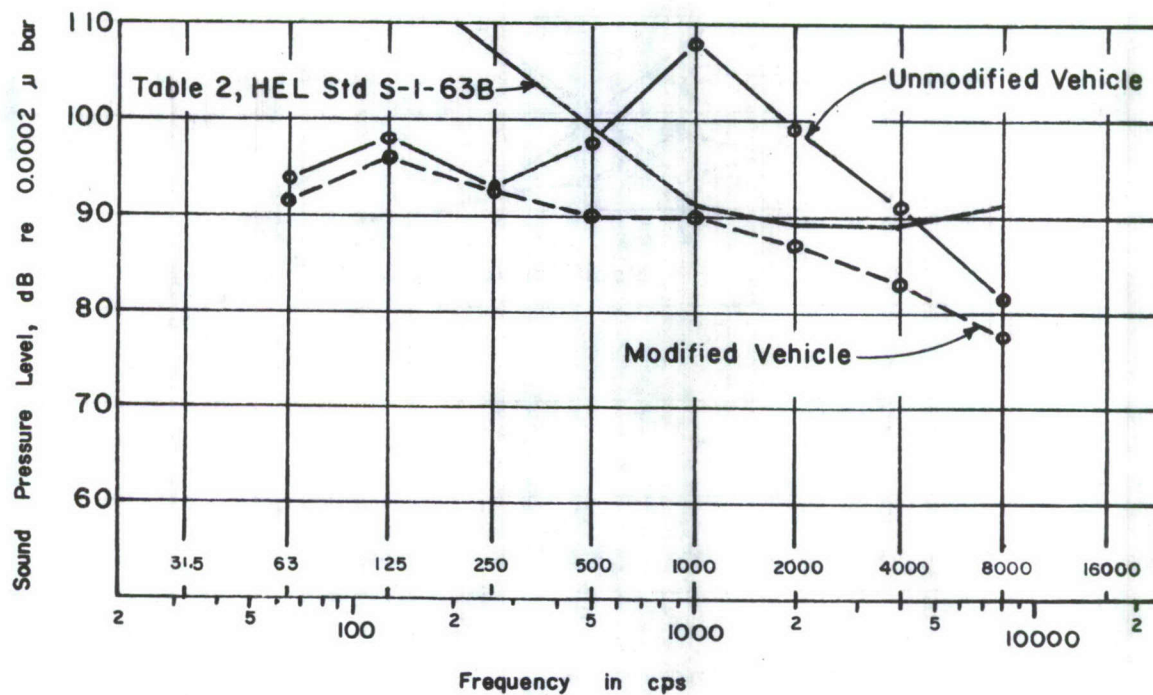
Fig. 27. OPEN CAB NOISE IN PILOT VEHICLE NO. 2 AT 3000 ENGINE RPM

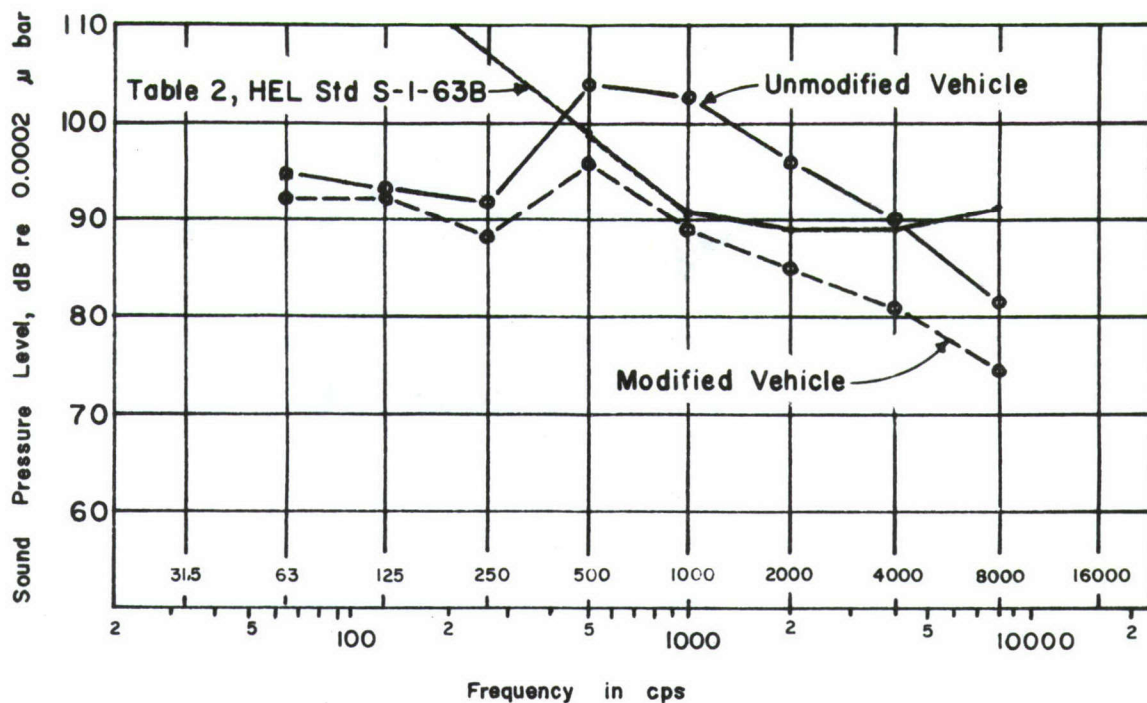
Fig. 28. CLOSED CAB NOISE IN PILOT VEHICLE NO. 2 AT 4000 ENGINE RPM
